Water Level Management Update

Pool 6 Drawdown –The Fifth Time was the Charm

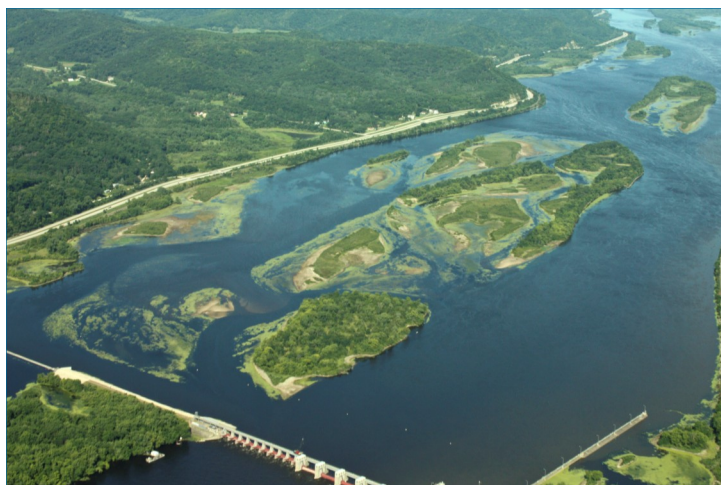
Aerial View of lower Pool 6 on July 16, 2010. The drawdown only affected the portion of the pool below Winona, MN. The area exposed appears as tan edges around the islands. Wisconsin DNR photo

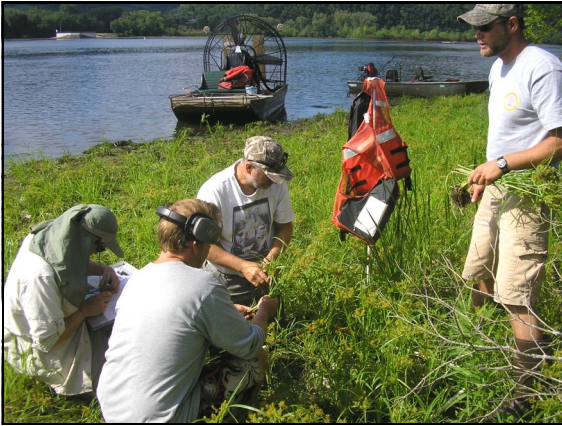
U.S.G.S. photo

During August and September 2010, scientists from the U.S. Geological Survey (USGS), Upper Midwest Environmental Sciences Center (UMESC) monitored the response of vegetation on substrates exposed during the 2010 drawdown on Pool 6. The evaluation is on-going, however some preliminary results are available.

Aerial photography on July 27, 2010 (the approximate time of peak drawdown) allowed researchers to assess the extent of sediment exposure and determine how much and where emergent and moist-soil plants responded; preliminary estimates suggest that 133 acres of substrate were exposed.

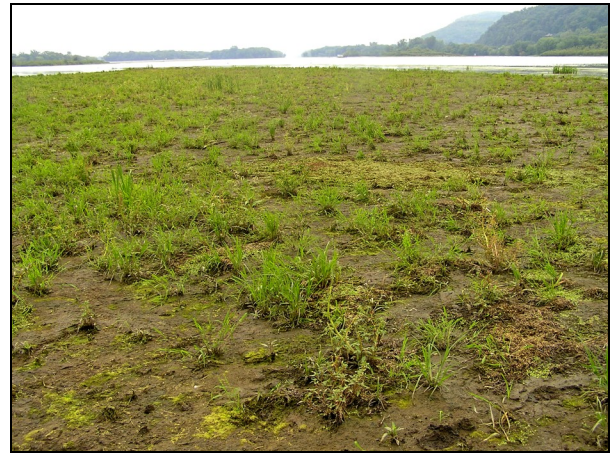
U.S.G.S. photo

Vegetation response was monitored by collecting and identifying all the plants inside a square frame at 141 randomly chosen sites. At the sample sites, the average length of exposure was 22 days, and ranged from 1 to 66 days. These sites were dominated by submersed, moist-soil, and floating-leaved aquatic species.

Researchers identified 79 plant species. The most frequently observed species were grassleaf mudplantain, Canada waterweed, coon tail, rice cutgrass, curly-leaved pondweed, reed canary grass, and white waterlily. Other common moist soil species included redroot flatsedge, chufa flatsedge, and nodding smartweed. Emergent perennial species such as sessilefruit arrowhead, common arrowhead, and broadfruit bur-reed were less frequently observed.

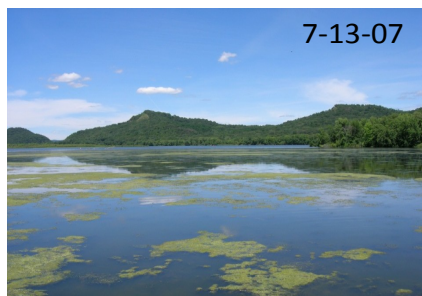
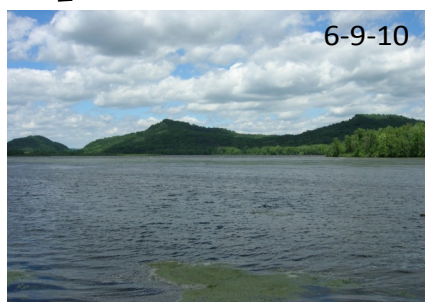
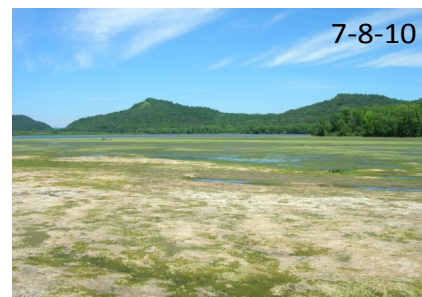
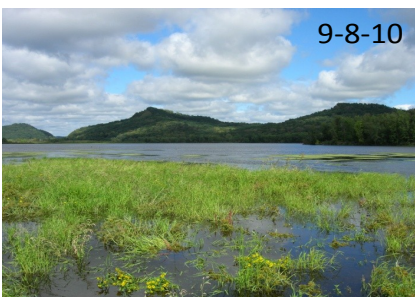
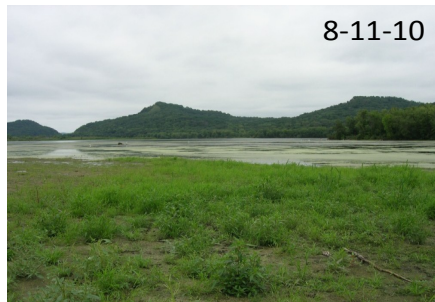
Pool 6

For each pool, photos were taken one or more years in advance of any drawdown activity. These photos provide an excellent reference condition. During the drawdown year, a series of photos are taken prior to, during, and following the drawdown. Photos are also taken in years following the drawdown.

Photo series provide managers with a quick snapshot of where and what kind of plants grew on the exposed soil, how thick they grew and how long they persist. However, just like the duck hunter, these photos also provide a sense of anticipation of what the changes will mean for fish and wildlife.

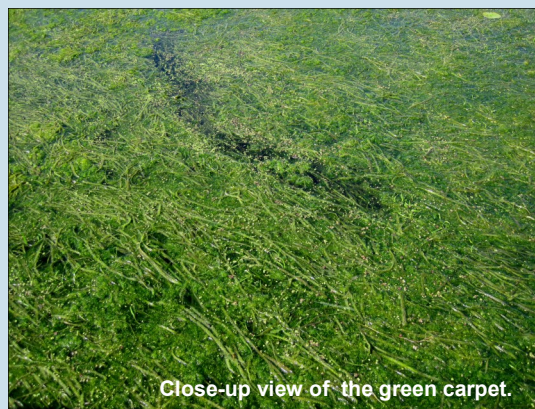
Close-up view of the green carpet.

Periods of calm winds, hot weather and an ample supply of nutrients provided the ingredients for the development of the green carpet of algae and duckweed that formed by late July in Pools 4-10.

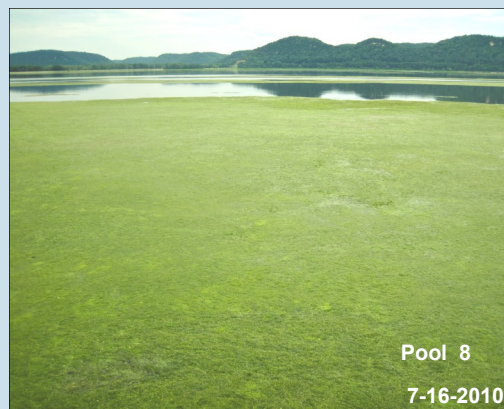
Pool 8

The heavy rainfall in mid August raised the water level of the river. The increased current combined with strong storm winds uprooted aquatic plants in backwaters and the main channel border. As a result there was a tremendous amount of underwater vegetation, duckweed, and algae moving downstream which caused problems from Pool 4-Pool 10.

7-16-2010
